Grower 101: Pressure-Treated LUMBER

How the transition in pressure-treated lumber standards and new alternatives will affect greenhouse and nursery growers.

By John W. Bartok, Jr.

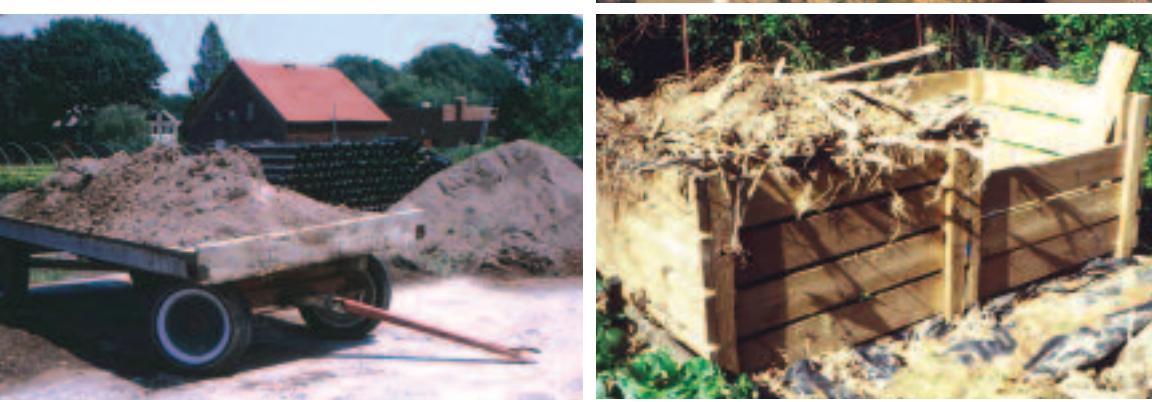
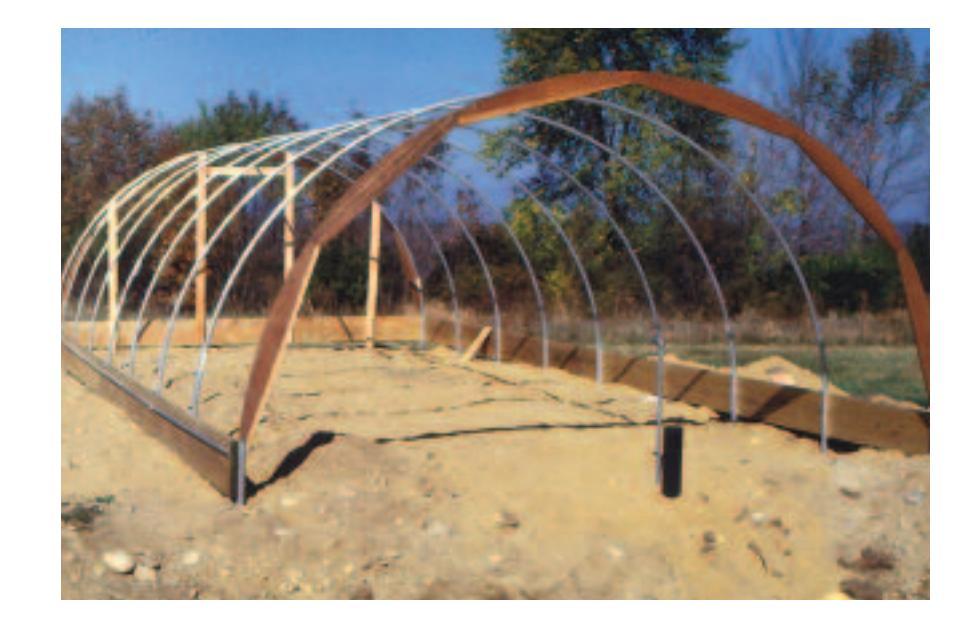
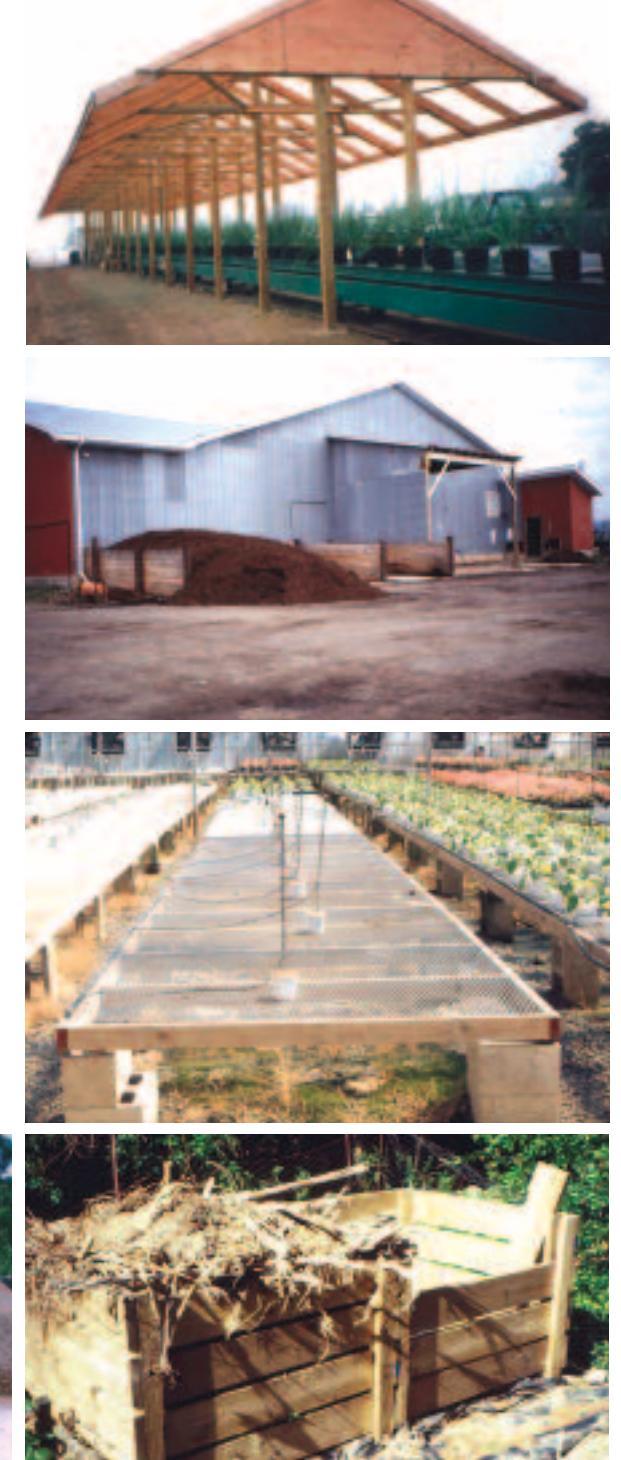
Clockwise from top: Skirt boards require treated lumber with at least 0.60 lbs./cu.ft. of chemical retention; posts in this shipping conveyor shelter should be pressure treated to give a long service life; soil and mulch bins should be built from a non-CCA treated material; pressure-treated lumber is a good choice for benches; use ACQ- or CA-B-treated lumber for compost bins and raised beds; trailer beds that are exposed to the weather will have a longer service life if built from pressure-treated lumber.
